Product Service Bulletin

Bulletin Number : **PSB-6**

Subject : Vigil Cutters

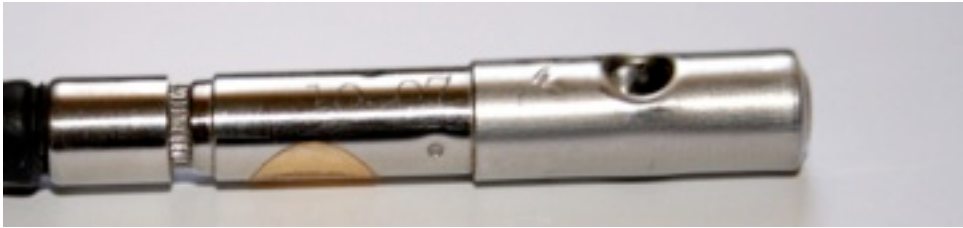
Picture 1

Vigil AAD, All Cutters produced in October 2007
Part Number: 9582006
Date of Manufacture: 10-07 (**mm-yy**)
See picture 2.

This cutter was part of a production batch of 299 pieces, produced in October 2007 (Picture 1).

In the interest of safety, AAD has decided to recall all cutters from this batch and to replace all those cutters free of charge.

Also some cutters could have a silver hologram because they were used for stock or replacements purpose via our dealers. Therefore verification on a next repack of the DOM on the cutter should be done. Every cutter with DOM 10-07 must be returned and replaced.

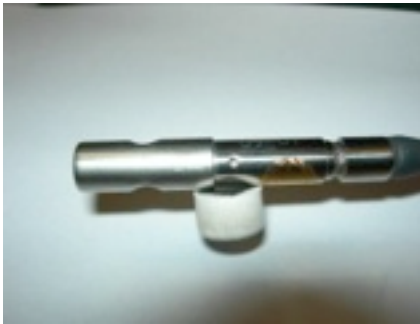
We found an easy way to do an additional safety verification in the field. This test can be performed on any Vigil cutter by using a magnet to guarantee the presence of a knife or not. It can be done with any magnet on any cutter if needed. A small light magnet (see picture 2A) or a bigger strong magnet (see picture 2B) can be used. If there is a knife present the knife will be attracted to the magnet.

For safety reason we recommend to do the magnet test on the cutters made before June 2008.
